A rare, but correctable, malfunction of a pacemaker

# An unusual case of upper rate behaviour

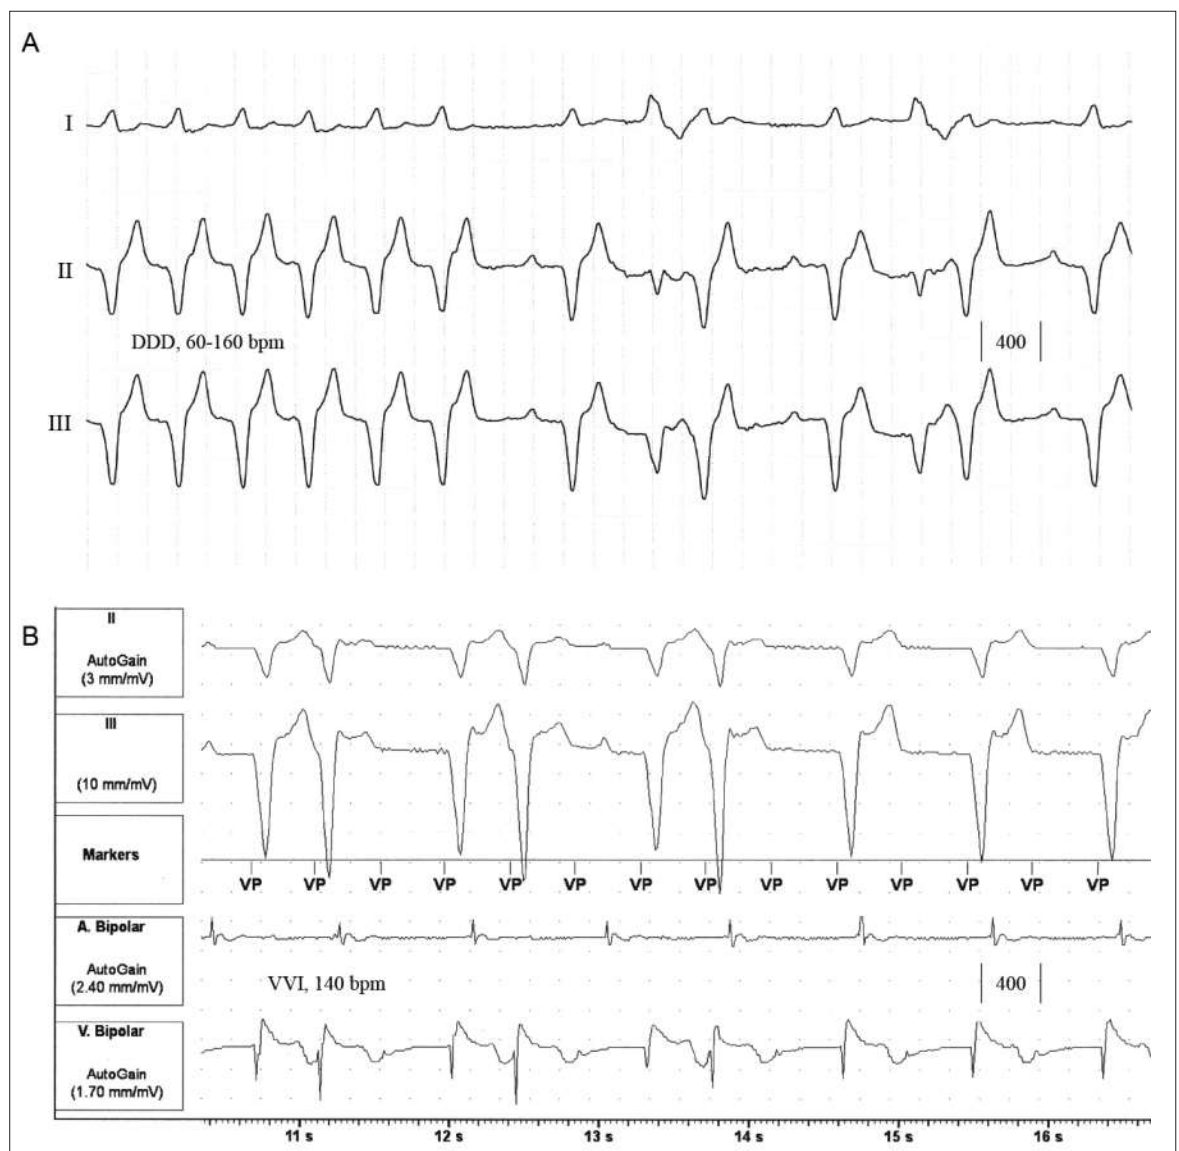
**Figure:** Tracing A: ECG at exercise stress test with sudden onset of a 2:1 block and occasional appearance of late coupled beats with a different QRS morphology (most likely delayed afterdepolarisations) at a heart rate of 135 bpm. Tracing B: Pacing in VVI mode (maximum output of 7.5 volts and maximum pulse width of 1.5 milliseconds) with loss of 1:1 ventricular capture and onset of first 3:2 followed by 2:1 ventricular capture at heart rate of 140 bpm.

carditis. An exercise stress test revealed a sudden onset of a 2:1 block at a heart rate (HR) of 135 bpm (fig. 1, tracing A). Interrogation of the pacemaker revealed normal and stable parameters for atrial and ventricular sensing, pacing thresholds and lead impedances. The maximum tracking rate (MTR) was programmed at 160 bpm and the total atrial refractory period (TARP) to 340 ms (corresponding to a HR of 176 bpm). Pacing in DDD and VVI mode at different HR (unipolar and bipolar pacing up to maximum output of 7.5 volts and maximum pulse width of 1.5 milliseconds) revealed loss of 1:1 ventricular capture at HR above 140 bpm (figure, tracing B). However, using the noninvasive programmed stimulation (NIPS) module of the pacemaker with the same output settings, 1:1 ventricular capture could be observed at any HR up to the shortest tested stimulation cycle length of 300 ms (corresponding to a HR of 200 bpm). With the support of the pacemaker manufacturer, the pacemaker's software was reset, which restored normal function of the device.

In dual-chamber pacemakers loss of 1:1 AV conduction at fast HR, also called upper rate behaviour, is determined by the MTR and the TARP [1]. In the present case, however, the symptomatic rate drop during exercise was due to an error in the device's software, which prevented 1:1 delivery of the electrical impulse at HR above 135 bpm. With technical support from SJM, the reason for the error was found in a random memory corruption of the pacemaker's software which set the runaway protection (RAP) value to 132.3 bpm. The RAP cir-

cuit is a fail-safe mechanism that defines the maximum pacing rate and prevents inappropriate delivery of rapid pacing pulses at extremely short cycle lengths. When the required pacing rate exceeds the RAP value, the RAP circuit prevents the pacemaker from delivering pacing pulses and so generates "exit block". The device continues to display ventricular pace markers on the ventricular channel but will deliver pacing pulses only when the RAP circuit timer has recovered [2]. When the device is initially manufactured the RAP value is at 132.3 bpm (reset value) and then is programmed typically to a nominal value of approximately 190 bpm. The RAP value is not reported by the device and can be altered when the memory is corrupted by electromagnetic interference [2]. The RAP value can only be reprogrammed via a password-protected engineering interface on the standard programmer, as performed in our case. Up to now only five cases with this specific problem have been reported to the pacemaker manufacturer and occurred in SJM Zephyr™, Victory™, and Identity™ devices.
