What to do with a redundant pacemaker...

To explant, or not to explant, that is the question

Simon von Gunten, Jean-Luc Crevoisier, Michael Kühne, Tobias Reichlin, Stefan Osswald, Christian Sticherling, Beat Schaer

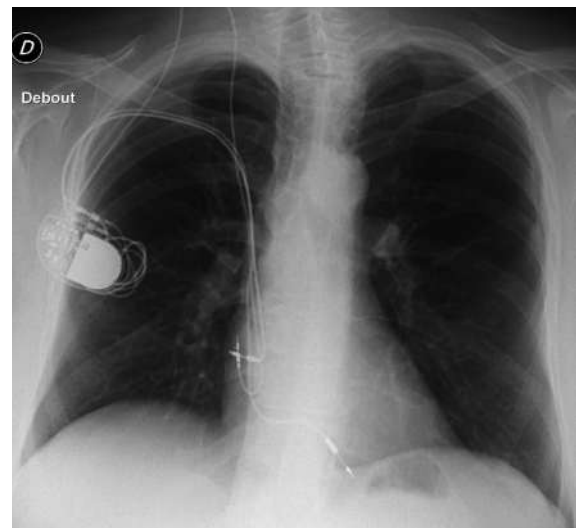
In 1991, a 65-year-old male patient was implanted with a dual chamber pacemaker for symptomatic persistent third degree atrioventricular block. Both leads were inserted via the right cephalic vein. Elective device replacement was first necessary in 2000. In 2007, the battery was depleted again. As an insulation defect of the atrial lead was present, lead replacement was planned at the same time. During surgery, the subclavian vein was found to be occluded, resulting in the implantation of a new atrial lead via the right internal jugular vein. In March 2015, the pacemaker battery was once more depleted. As the right ventricular lead now showed a slow, but continuous decrease in impedance (from 510 ohms in 2007 to 330 ohms in 2015), the patient was offered implantation of a new dual chamber pacemaker from the left side. Extraction of the leads was not considered for various reasons (age, comorbidities and access to one lead via the jugular vein). The patient did not express discomfort from the right-sided old device (fig. 1).

The pertinent question was whether the right-sided pacemaker should be left in place and programmed to

Figure 1: Chest X ray at presentation.

an ODO or OOO mode, or if it should be explanted. Arguments against explanting the pacemaker were that there was no obvious clinical need and that there is a statistical 1.4% chance of infection [1], double that associated with a *de-novo* implant [2]. This had to be balanced against possible interferences between the new pacemaker implanted from the left side and the old device falling below the “elective replacement indicator” (ERI) and then later going into its “end of life” (EOL) mode.

In our patient, the Medtronic pacemaker was explanted. Over a follow-up of 9 months, the course of the patient was uneventful.
